**Species: Red Oak (*Quercus rubra*) Location: [///ecologist.reverses.mats](https://ecologist.reverses.mats)**

**Species:** Ash (*Fraxinus excelsior*) **Location:** ///degrading.snug.deeds

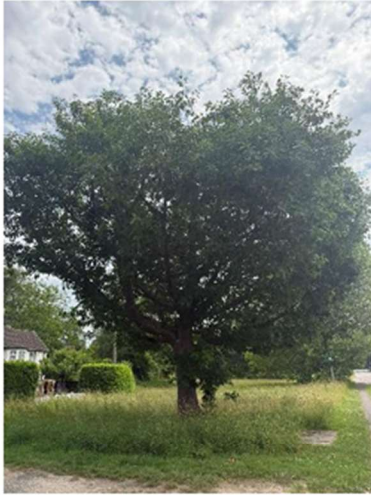
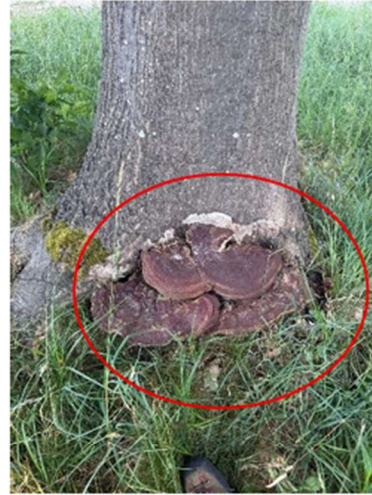
A visual inspection of the root-plate was undertaken on the 26/06/2026 identified fructification of *Ganoderma Resinaceum* at the base of the tree.

This fruiting body is known to cause extensive deterioration of the buttress and root system, severely compromising structural stability. Additional fungal brackets are present on the opposite side of the stem, indicating advanced colonisation and internal decay throughout the base.

**Risk Assessment:** Due to the tree's proximity to the highway and the extent of decay, there is a significant risk of structural failure, posing a hazard to road users and pedestrians

**Recommendation:** Fell to ground level.

A suitable replacement tree should be planted in a separate location to maintain amenity value.

**Timeframe – 1 month (As soon as possible)**

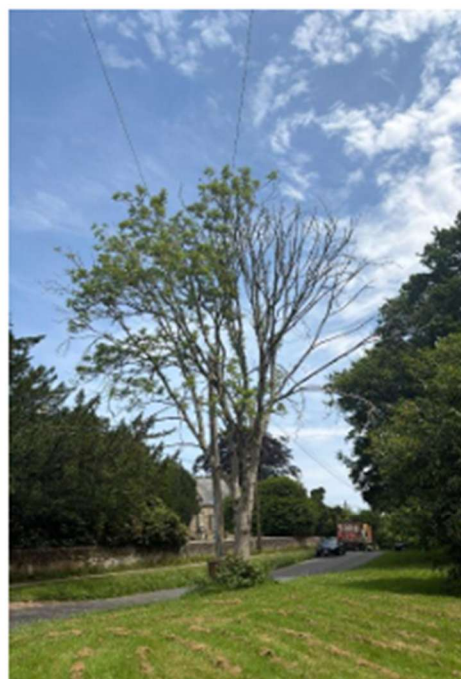
**Inspection Findings:** A visual assessment was undertaken on the 26/06/2026 which identified symptoms consistent with Ash Dieback (*Hymenoscyphus fraxineus*), including crown dieback and progressive decline of the upper canopy. Structural defects (major deadwood) were also noted within the stem and primary scaffold branches, typical of advanced infection. The disease is known to cause brittle wood, unpredictable limb failure, and progressive structural weakness as it develops.

**Risk Assessment:** Given the tree's declining condition and its proximity to the highway this presents a clear hazard to road users, pedestrians, and nearby telecoms units particularly during periods of high wind or heavy rainfall.

**Recommendation:** Due to the irreversible nature of Ash Dieback and the elevated risk associated with its structural deterioration, it is recommended that the tree be felled to ground level to remove the hazard.

**Timeframe – 1 month (As soon as possible)**
